INITIAL RADON AIR SAMPLING OF MALIN ELEMENTARY SCHOOL FOR KLAMATH COUNTY SCHOOL DISTRICT

2845 GREENSPRINGS DRIVE, KLAMATH FALLS, OREGON

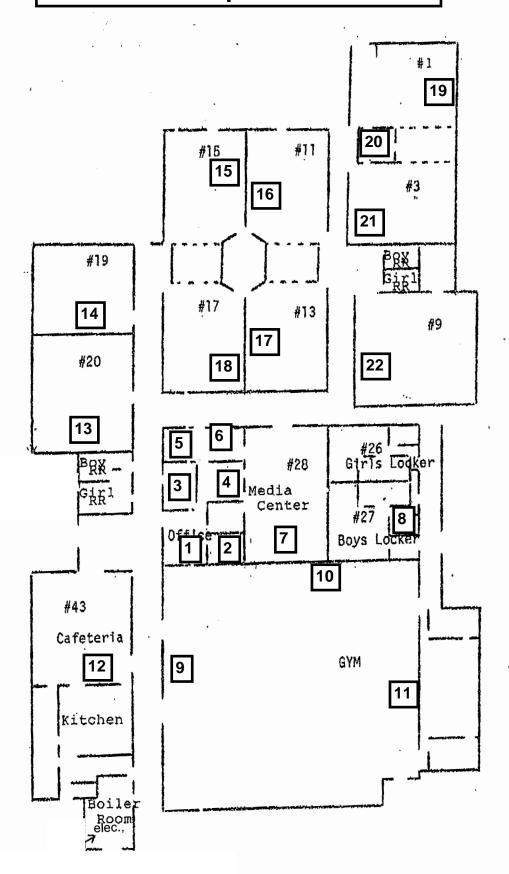
APPENDIX C RADON SAMPLING LOCATION DIAGRAM

MALIN ELEMENTARY SCHOOL Radon Sample Locations

The radon air test kit samples collected from MES building were reported ranging from <0.3 to 0.9 pCi/L (picocuries per liter of air). A complete listing of laboratory results and locations is found in the Air Chek, Inc. Laboratory Analysis Report in Appendix A.
